Smoke and Dye-Water Observation Summary

Western Run Pilot Project - Baltimore Maryland

INSPECTION REPORT

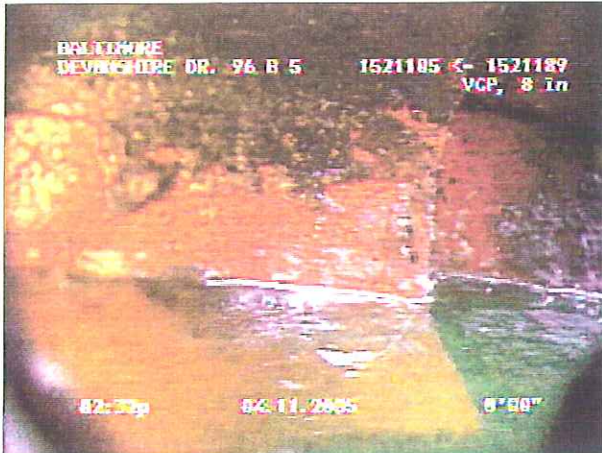
IMAGE: 2a, TAPE #: JAM 4, 00:00:29
0FT, Infiltration Seeping at joint at 04 o'clock

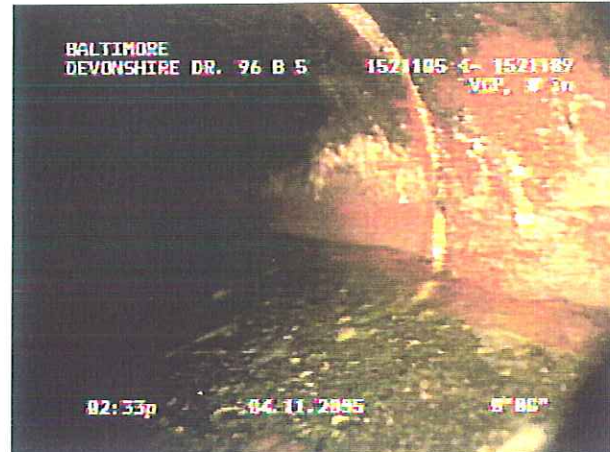
IMAGE: 3a, TAPE #: JAM 4, 00:02:07
3FT, Infiltration Running at joint from 04 to 08 o'clock

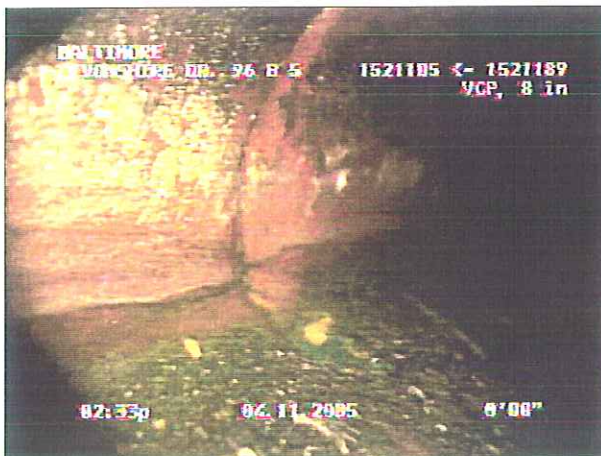
IMAGE: 3b, TAPE #: JAM 4, 00:02:07
3FT, Infiltration Running at joint from 04 to 08 o'clock

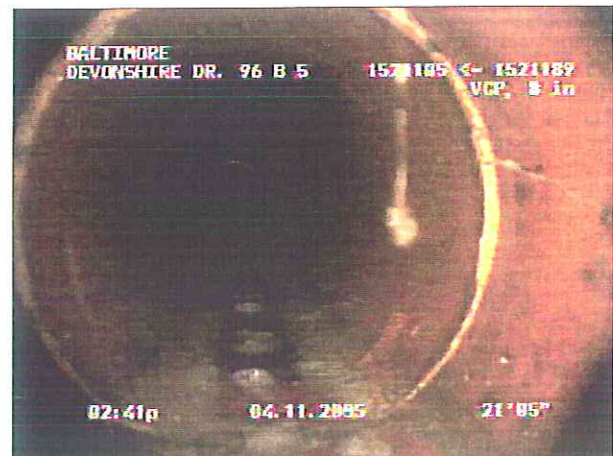
IMAGE: 7a, TAPE #: JAM 4, 00:04:27
21.43FT, inspection ends, NO MORE DYE TEST LEAKS SEEN.
